2200 FAIRWOOD AVENUE
— WAREHOUSE REPAIRS —
2200 FAIRWOOD AVENUE
COLUMBUS, OH 43207-1708

PROJECT
PROFILE

2007.008

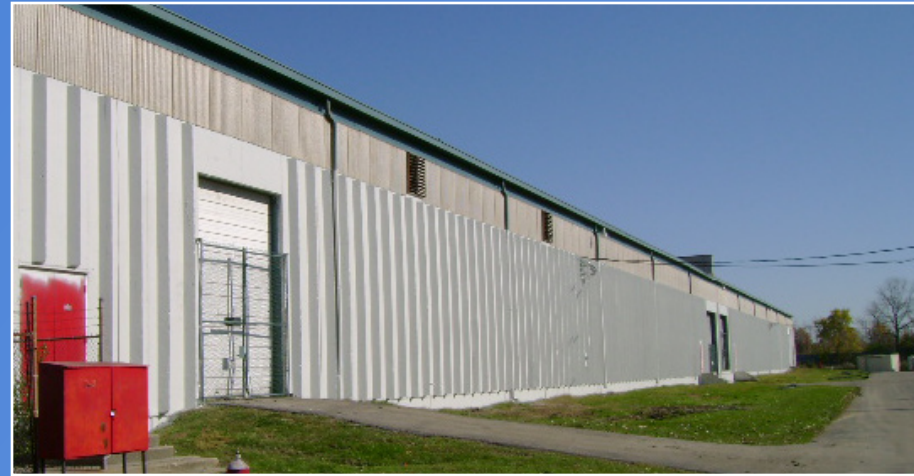
The building, constructed in 1969, utilized a fluted precast concrete exterior panel. These panels had not been properly maintained by previous owners and over time had suffered water damage. In order to repair them properly, We researched the issue & performed these services:

- ⊙ 261,440 square foot building
- ⊙ Exterior concrete panels around the perimeter of the structure repaired to restore durability and to prevent further water damage
- ⊙ Sealed and painted the exterior to restore the building appearance—a dramatic improvement

- ⊙ Panels thoroughly cleaned, then repaired with a specialty cement that had been reinforced with epoxy polymer
- ⊙ Primed and painted with finishes to restore durability and aesthetic appearance to the building
